Inspection Report
Minerals Regulatory Program

Mine Name: AMMI

Operator Name: Absolute Mining and Minerals

Inspection Date: May 19, 2005

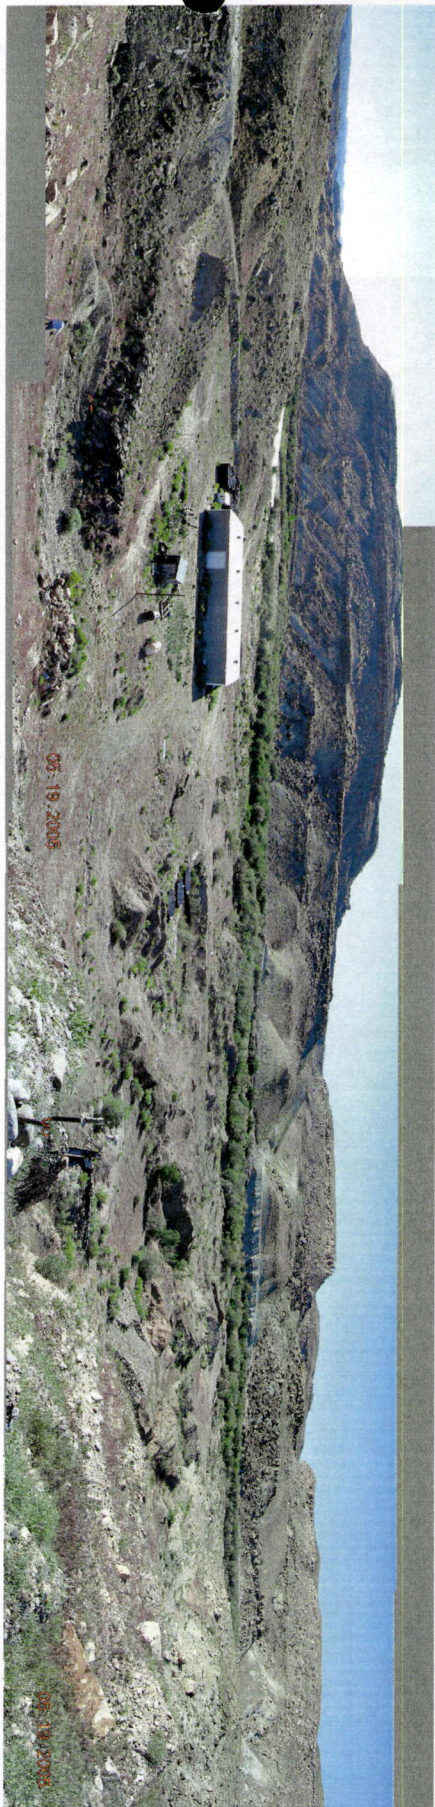
The site has changed little since the last inspection, and it does not appear there has been any recent activity. Photo 1 is an overview of the area.

Photo 1. A panorama of the mine site. This is a composite of five photographs, and there is some distortion. One of the places that was reclaimed in 2002 can be seen to the left of the building.

The operator needs to take measures to control the Russian knapweed. Otherwise, the problem will continue to grow, and it will be nearly impossible to control this weed at the time of reclamation.
